STABILIZATION OF LOWRY RUINS

ADRIAN S. WHITE
AND
DAVID A. BRETERNITZ

Mesa Verde Research Center
University of Colorado
Boulder, Colorado

March 1976

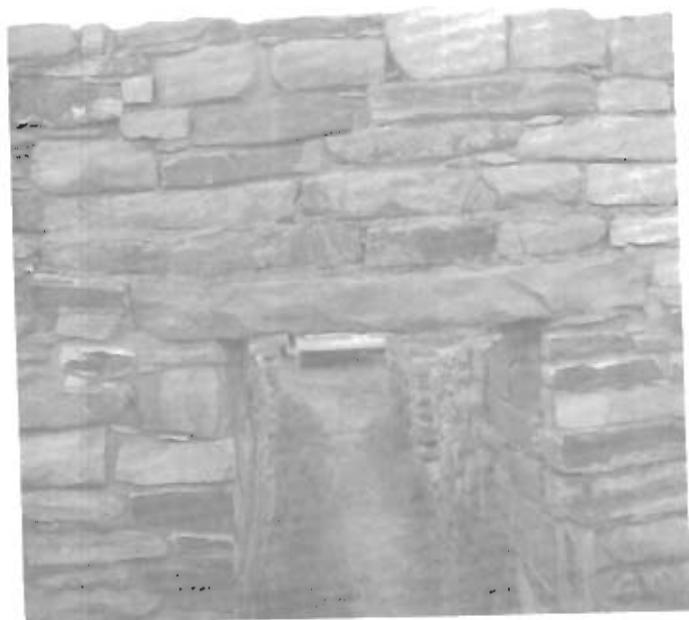
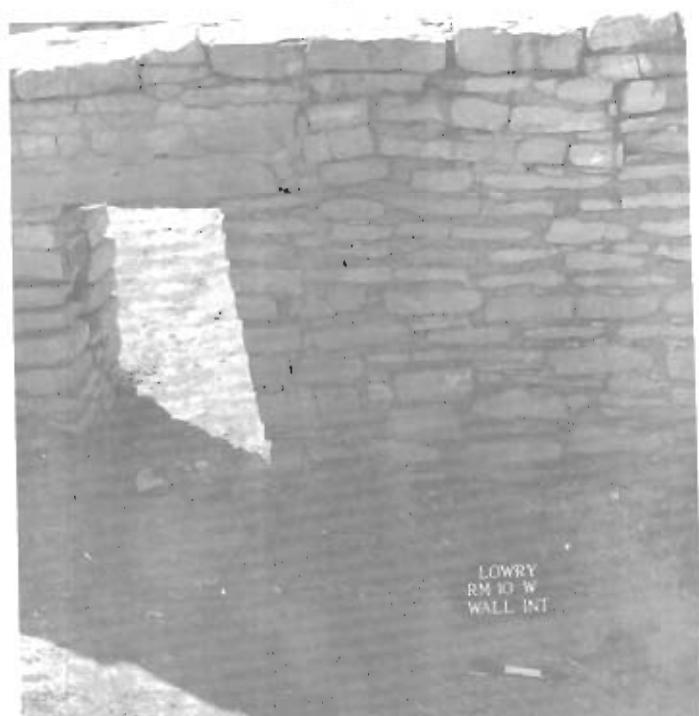
Figure 5. Doorways stabilized by Ben Williford, 1936. a, Room 10, east doorway; b, Room 10, west doorway.

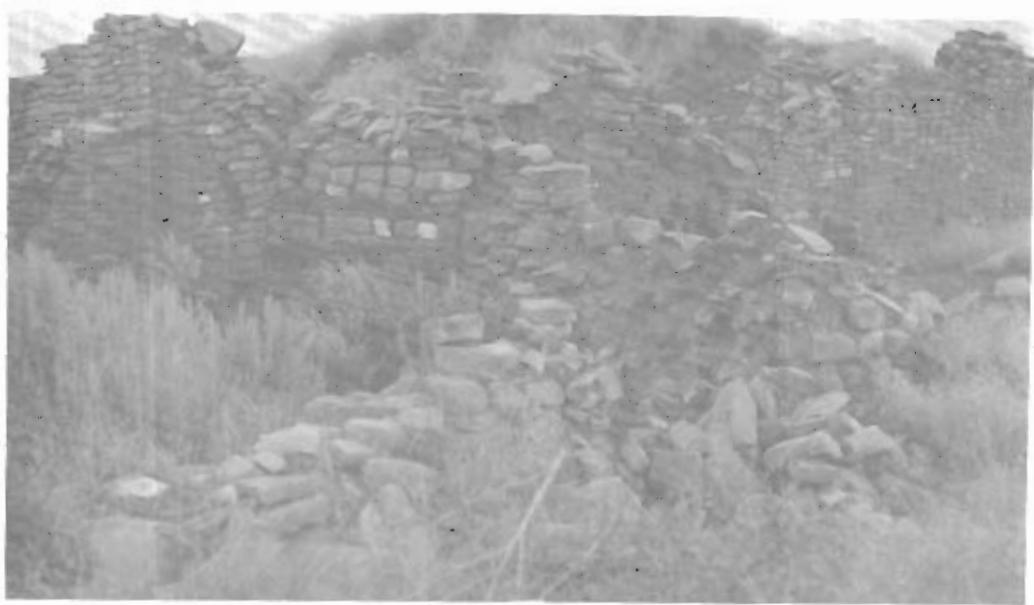
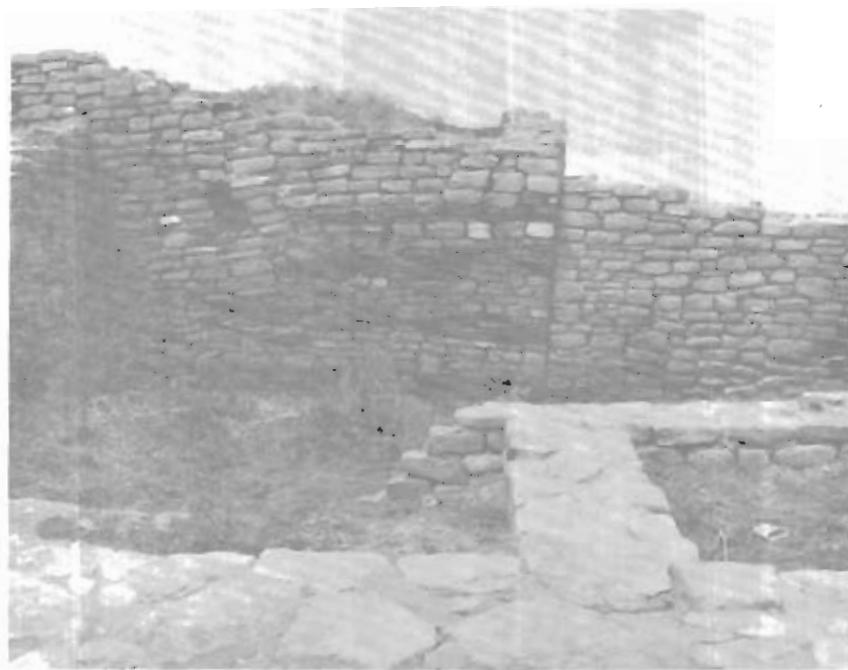
Figure 6. Room 9, north exterior wall, 1966. a, before stabilization; b, after stabilization.

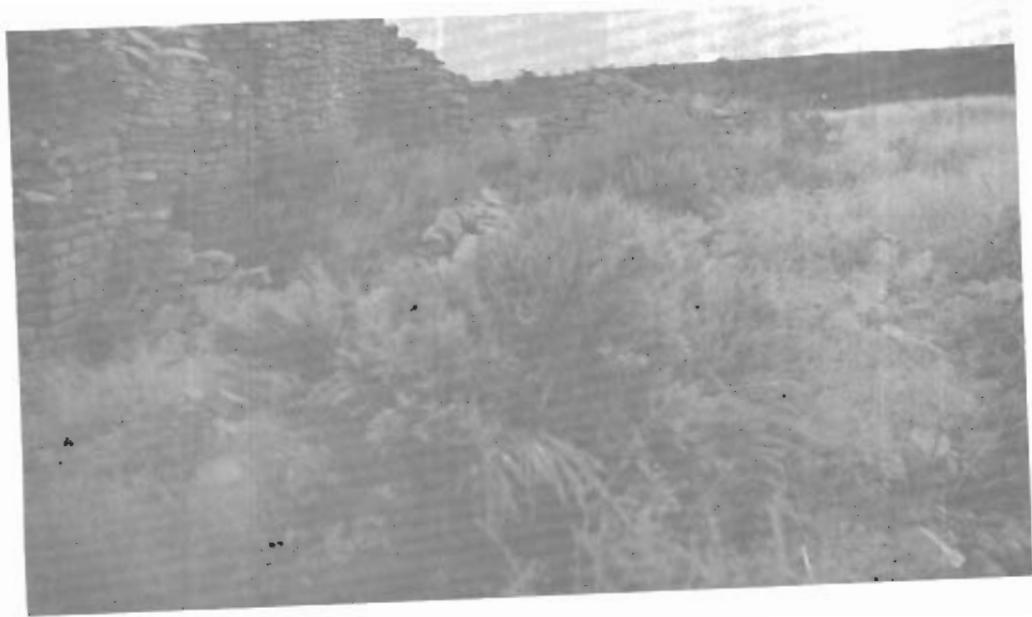
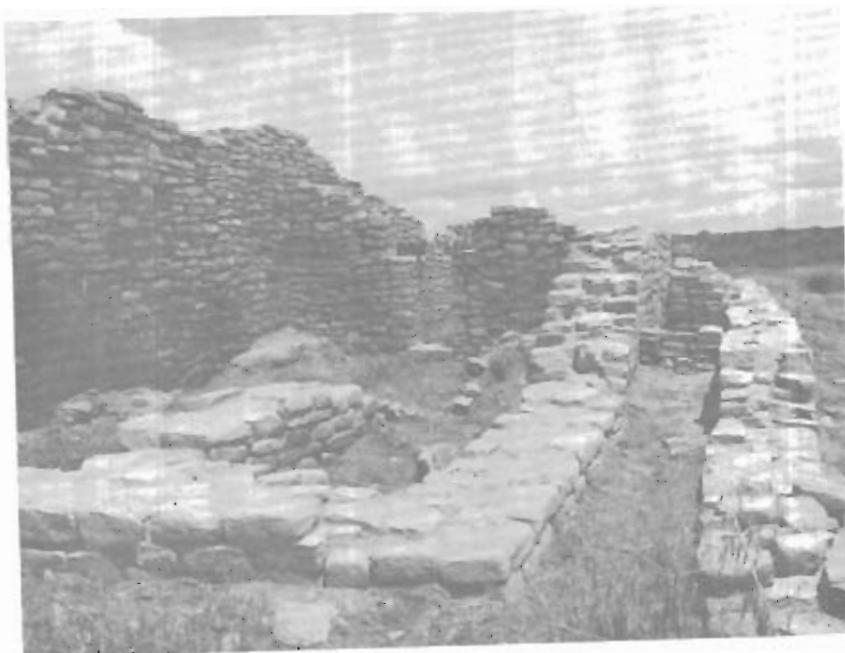
Figure 7. Lowry Pueblo, south end, 1966-67. a, before stabilization; b, after stabilization; Kiva H is not stabilized in this photo.

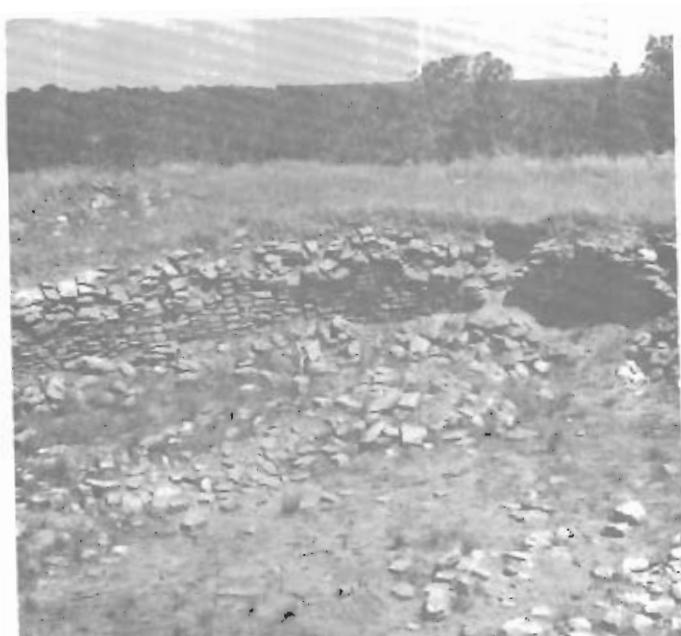
For the next 30 years no excavation or stabilization was done at Lowry. The elements caused rapid deterioration on the unsheltered ruin. Stones slipped from upper courses; prehistoric mortar crumbled; and lateral separation of walls occurred (Figs. 6-7). The Great Kiva eroded the most because it was constructed as a depression (Fig. 8).

The second season began in June, 1967. The Pueblo was completed and work began on the Great Kiva. The major reconstruction necessary to restore the Great Kiva is seen in Figure 8. Surface runoff down the walls and recessed stairway had caused rapid deterioration.

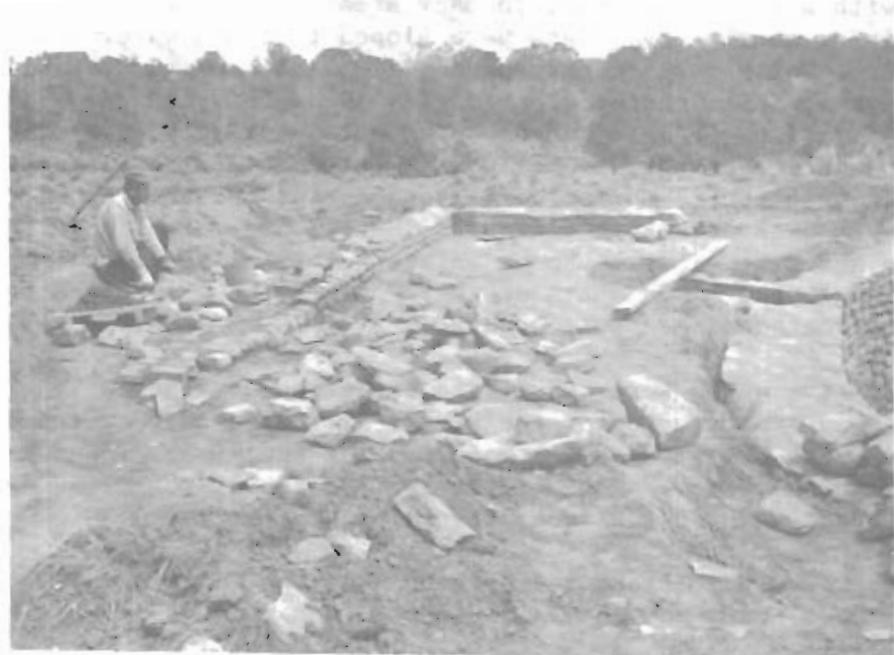
a

The Great Kiva walls were rebuilt to the ground surface with all moisture drained away from the top of the Kiva. All built-in features were repaired, with drainage to the main part of the Kiva. The poles were replaced in the steps. Rooms 1, 2, and 3 north of the Kiva were reconstructed with low walls of several courses (Fig. 9).

Figure 9. Great Kiva, 1967. a, room block to north during stabilization; b, walls were stabilized higher to the inside to drain water outward away from walls.

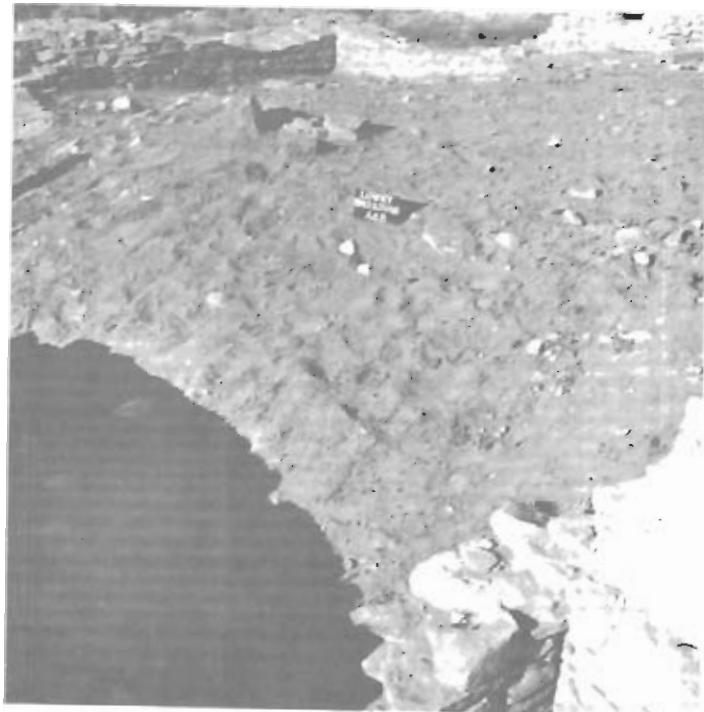
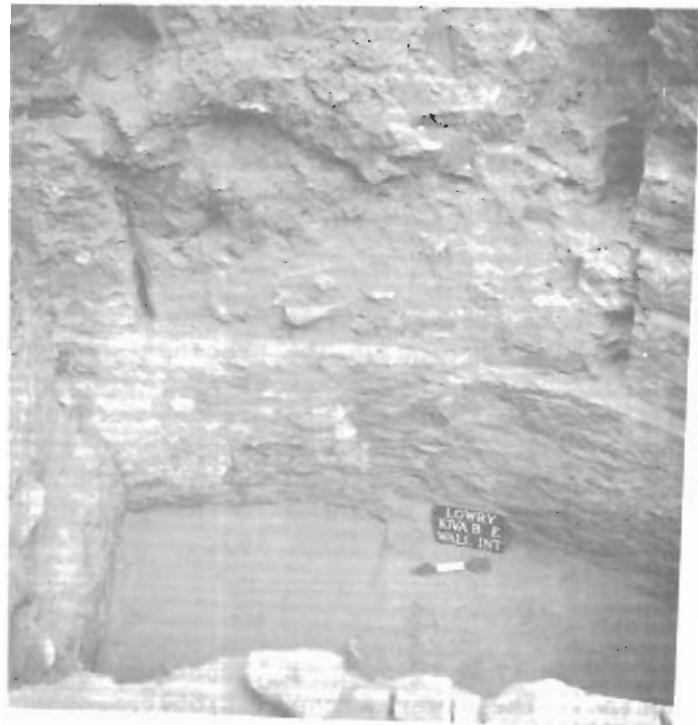
Figure 12. Kivas A and B. a, filled area above kivas before excavation; b, east side of Kiva B excavated to the floor (plaster has slumped off in this area).

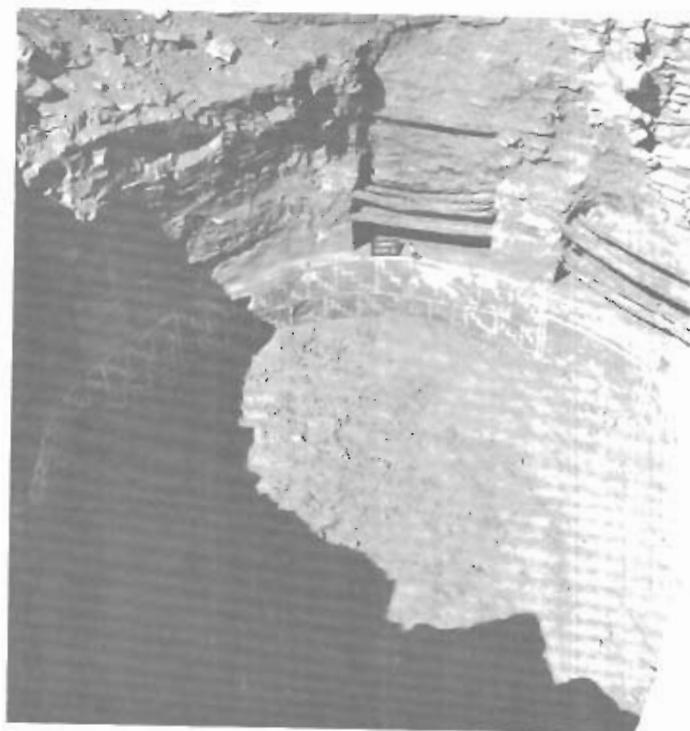
With the excavation of Kiva B the walls of Kiva A were almost completely removed, with only a small area remaining on the west side. Kiva B was excavated to 5-10cm above the floor. The benches were cleaned and the murals were photographed (Fig. 14). The condition of the murals was excellent in the areas that had not previously been excavated. Those areas that were lacquered showed damage primarily between the first and second pilasters. Painting the murals with shellac created a hard frontal surface which caused the plaster to separate from the stone wall and other layers of plaster. The presence of moisture, dirt, and roots behind these separated areas increased deterioration. When these areas were excavated, the plaster either crumbled or gradually began to break down as it dried out; no successful process has been discovered to stop this type of deterioration.

Figure 14. Kiva B. a, north view of murals after excavation in 1974; b, close-up of damaged area where plaster is peeling from the walls.

In order to recover as much of the design as possible, tracings were taken of the murals in sections. The tracings show what design remains, the areas cracked, and in some instances a previous design where the plaster had broken off. Close-up photographs were also taken of the entire bench (Fig. 15). A color sample was taken of the plaster. As soon as the murals were recorded, they were covered with strips of plastic sheeting, which were anchored to the tops of surrounding walls and draped down over the murals (Fig. 16).

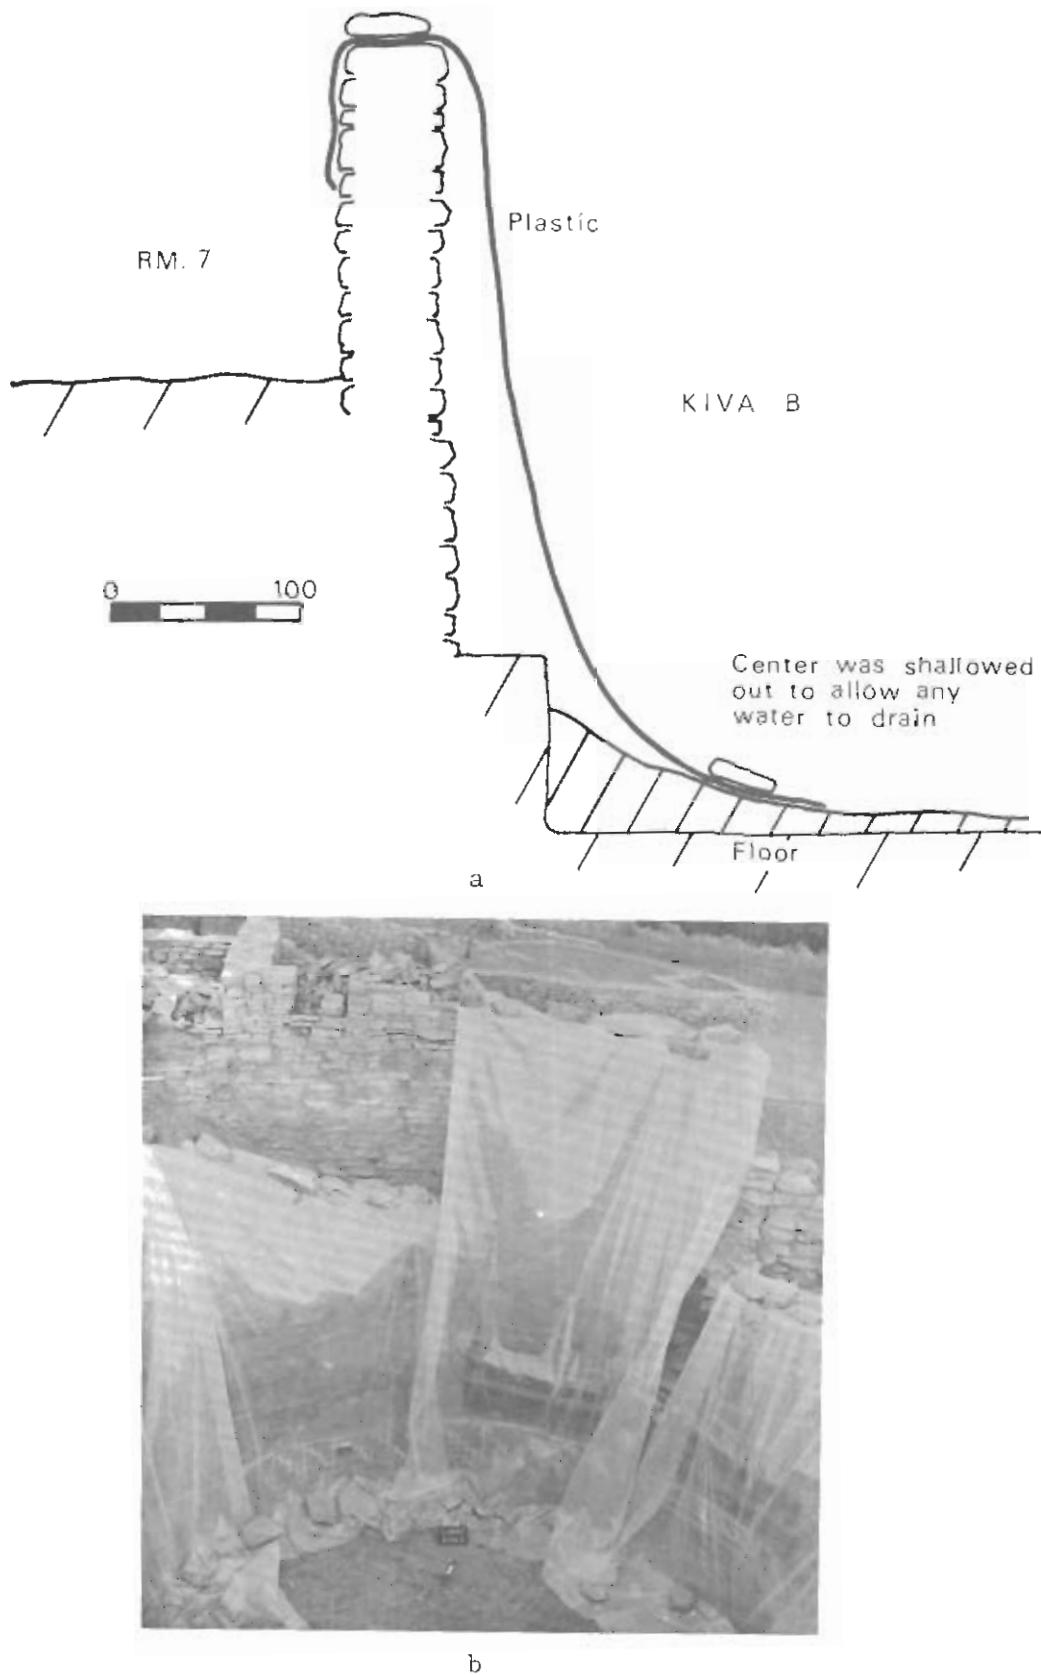
Figure 16. Kiva B. a, north-south profile of plastic sheeting over murals; b, north view of plastic sheeting secured with stones to the top of surrounding walls and draped over murals.

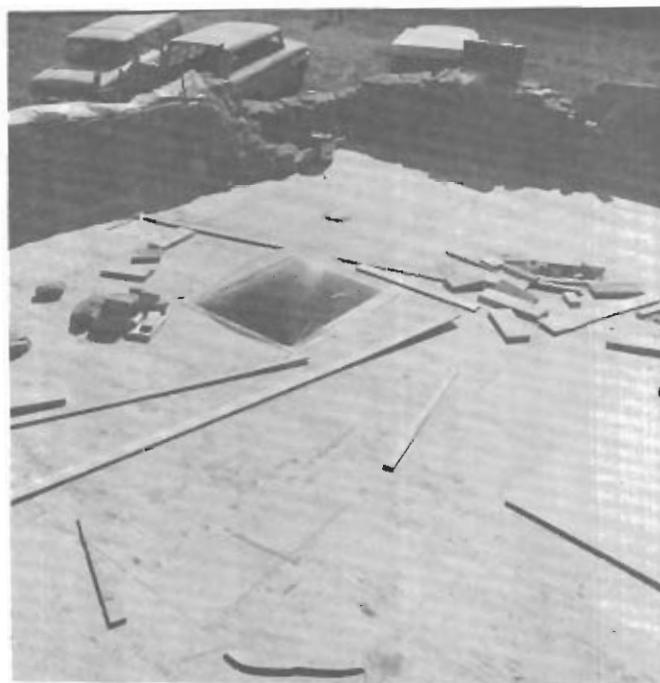
b

Figure 28. Kiva B, permanent roof. a, profile of plastic bubble; b, northeast view of plastic bubble secured to roof.

Plastic Bubble: A four-foot frame of 2" x 4" was built as a base for the skylight. The frame was secured on top of the plywood. The bubble was then screwed to the frame (Fig. 28).

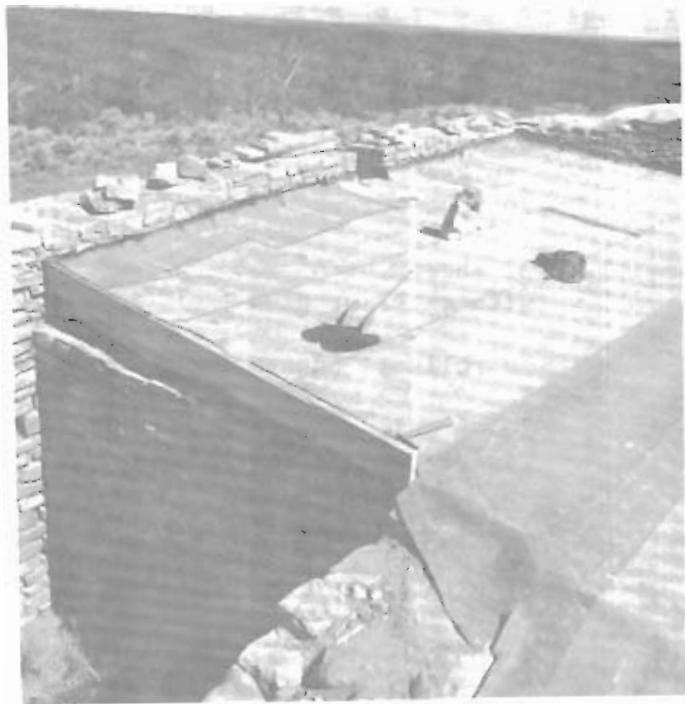
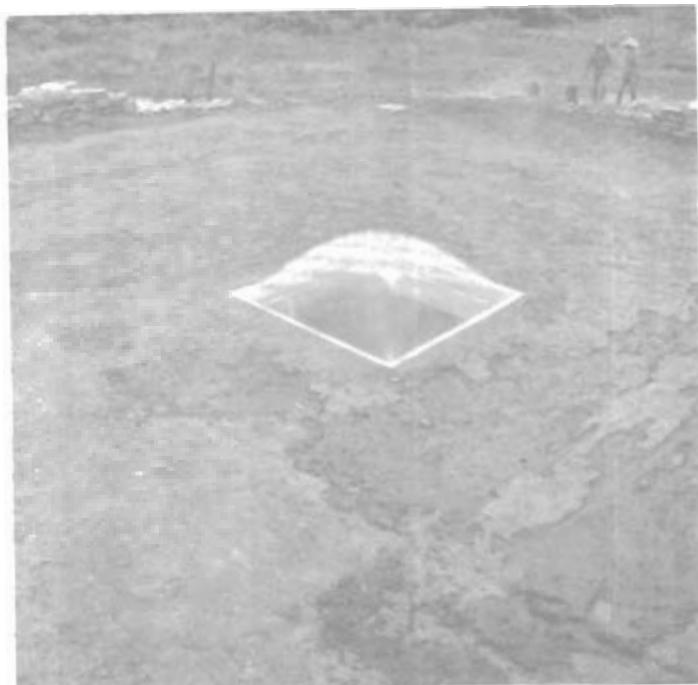
Figure 29. Kiva B, permanent roof. a, north view of tarpaper layer and areas sealed with plastic cement; b, after addition of dirt layer.

Tarpaper: Strips of tarpaper were laid over the plywood and secured to the nailers. Plastic roofing was used to seal the joints around the edges of the roof and particularly around the bubble (Fig. 29).

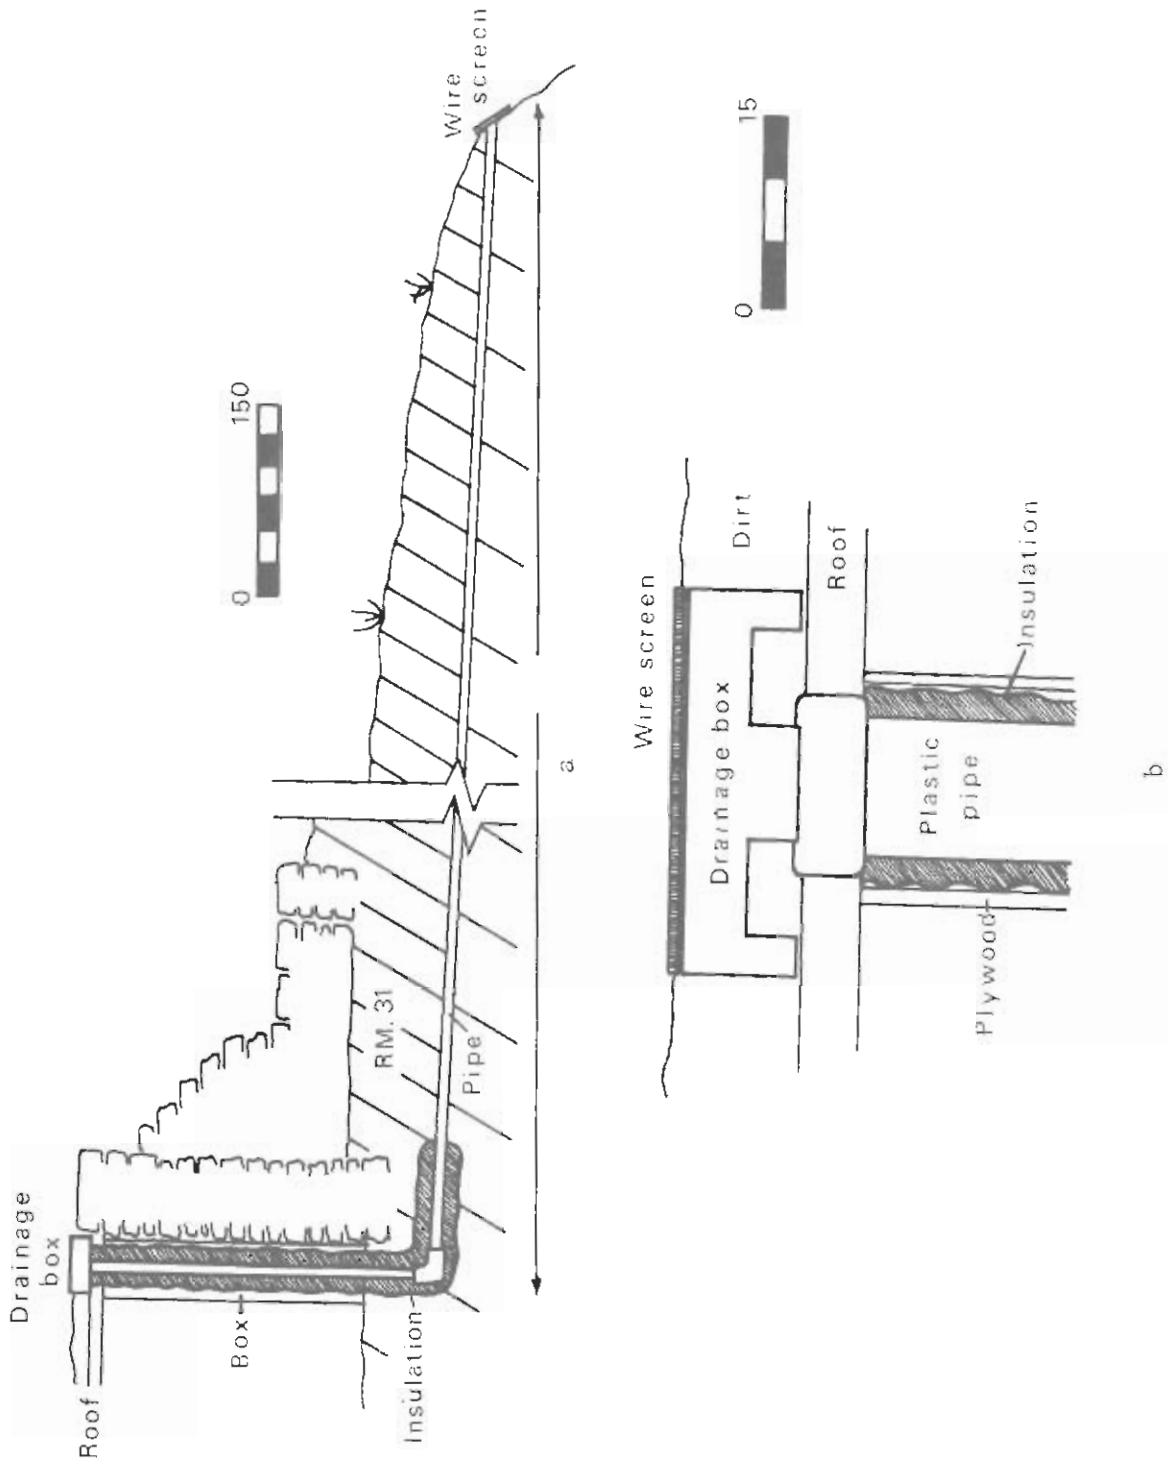
Figure 30. Kiva B, drainage system. a, east-west profile of drainage route; b, east-west profile of drainage box.

Dirt: 10-15cm of dirt were put on the roof (Fig. 29). A drainage pipe was screwed with a coupling into the southeast corner of the roof that extended 90-15cm below the surface, made a 90° turn, and extended along the north wall of Room 31 to 8m beyond the Pueblo. A drainage box was placed over the pipe into the roof (Fig. 30). The pipe was wrapped in insulation and the portion left exposed was covered with a plywood box.

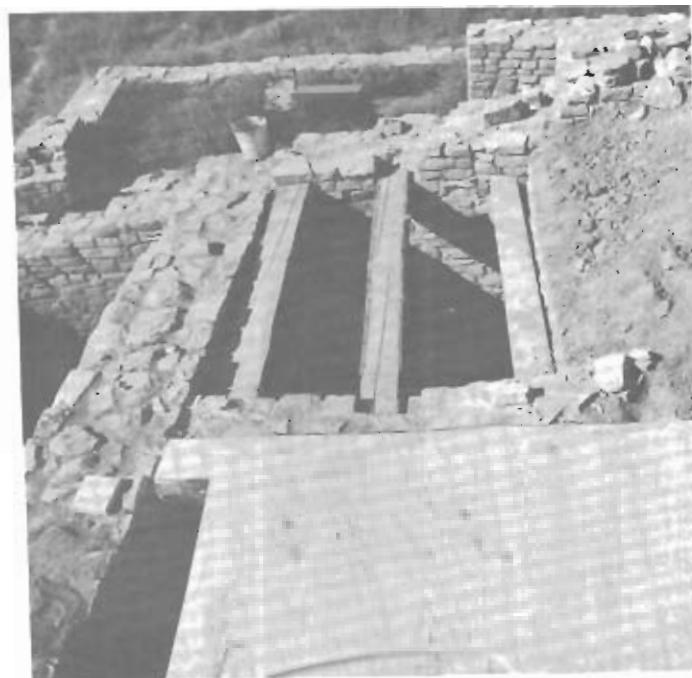
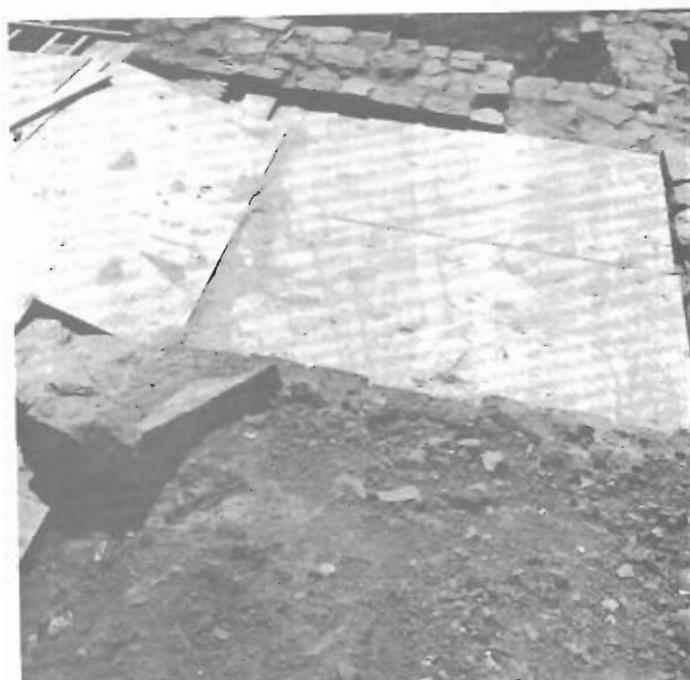
Figure 31. Room 27, permanent roof. a, south view of beams set in sockets over room; b, west view of plywood roof.

Room 27 was roofed with Kiva B. Six sockets were chiseled out of the north and south walls for the rafters to rest on; the rafters were three spruce timbers 8'6", 8'9" and 8'11" in length set in a bed of cement. Two sheets of plywood were laid directly on the beams (Fig. 31); a quarter roll of tarpaper was nailed to the nailers. A wing wall of 2" x 6" rafters connected this roof to the roof over Kiva B, making it continuous. It was covered with 10 to 15cm of dirt (Fig. 26).

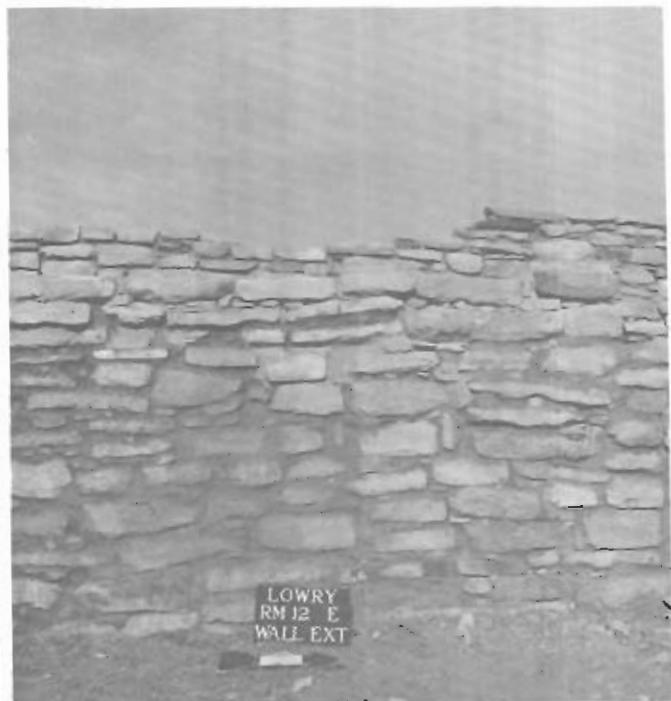
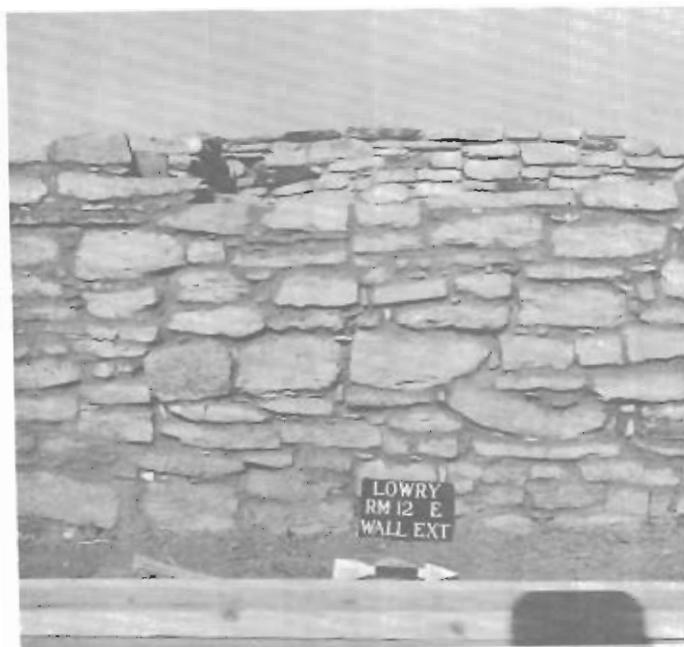
Figure 34. Room 12, east exterior wall. a, northern portion of wall after stabilization; b, southern portion of wall after stabilization. No before photograph was taken; the wall can be seen in Fig. 35.

- A. Erosion has occurred in the eastern area of wall which was abutted to NE corner of Room 12. Four to five courses in width by 1 m. 30 cm. in length require replacement.
- B. A small patch was needed on S wall of Rm. 18

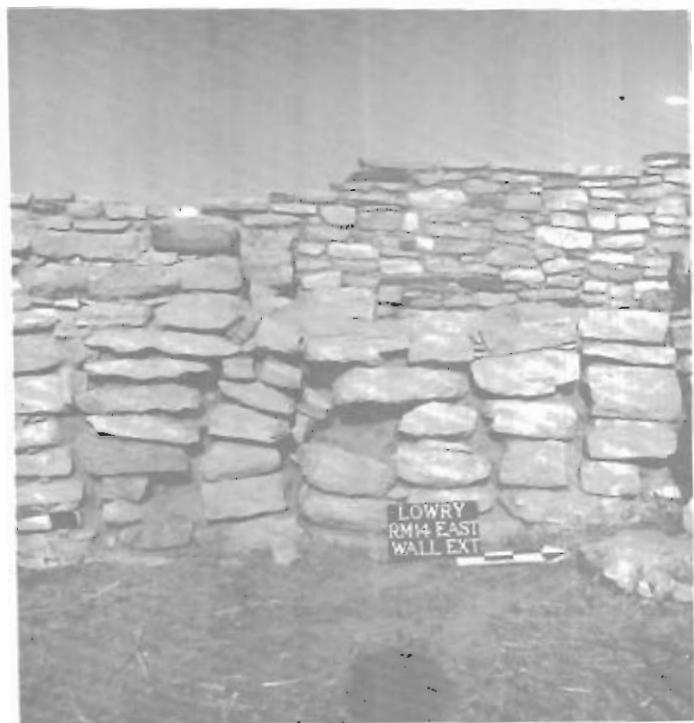
- A. The east exterior wall of Room 14 is capped on the upper 2 courses. The lower courses are composed of prehistoric masonry. Stones beneath the capped area are loose and the soil mortar is falling out and flaking off.
- B. No prehistoric masonry remains in the arch of patch on the south wall of Rm. 18.

Figure 35. Room 14, east exterior wall. a, several stones were missing and large joints were created by crumbling mortar; wall was slumping at the abutment to Room 12; b, missing stones were replaced and the wall was straightened.

- A. East Ext. wall of Room 14 - all loose stones were removed and reset with a mixture of Portland cement and sand. The area reset was approx. 4-5 courses in height. Area was pointed with a soil mortar of 3 parts soil to 1 part sand.
- B. South Int. wall of Room 18 - several stones were reset with a mixture of Portland cement and sand.

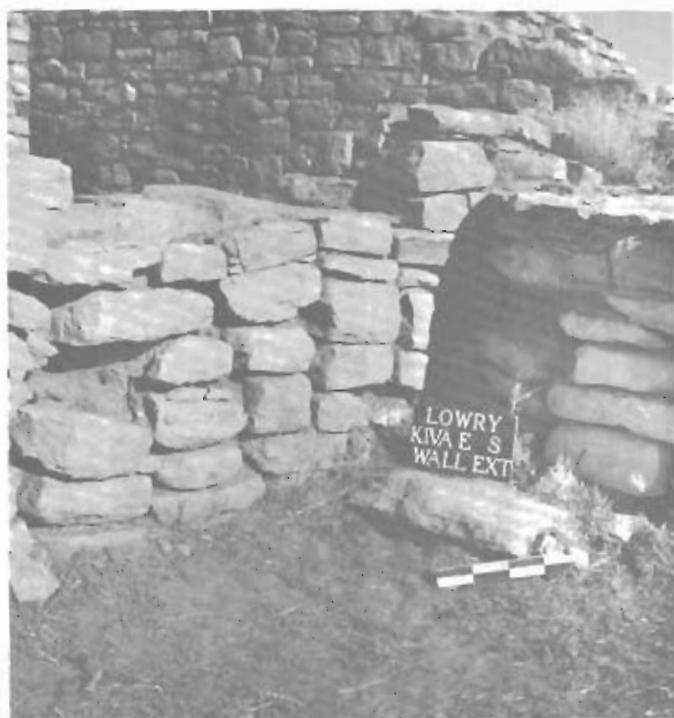
- A. Building stones had fallen in central area of wall from the 3rd to 8th courses. Soil mortar was in a crumbling state with stones loosened and several missing. Large joints were created by missing joints.
B. No prehistoric masonry remained, entire SE corner of this wall was set in cement in 1966.

Figure 36. Kiva E, south exterior wall. A, several stones were missing and large joints were created by crumbling mortar; b, stones were reset and all large joints were filled.

- A. All loosened stones were removed along with all loose soil mortar. Stones were reset with a mixture of Portland Type I and II cement and Shiprock sand. All newly cemented joints were pointed with soil mortar of 2 parts soil to 1 part sand.
B. Loosened stones were removed and reset with mixture of Portland cement and Shiprock sand. Area was pointed with soil mortar of 2 parts soil to 1 part sand.

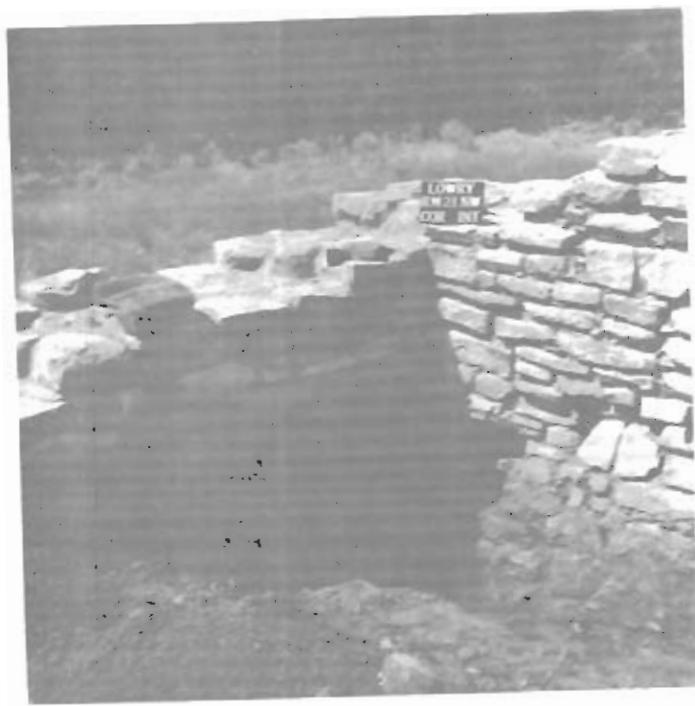
Corner of Rm. 21 showed cracking of soil mortar and concrete prior to trench being dug along wall below soil level of room. The trench showed intensive erosion had occurred in the portion of wall below soil level. A large crack ran between the 5th and 6th course. Overall view of wall indicated wall was blumped outward and downward.

Figure 38. Room 21, northwest interior corner. a, large area of missing and fallen stones caused by undermining; b, stones were reset and pointed with soil mortar, soil was banked against the wall and sloped towards the center of the room.

Corner was stabilized by removing loose stones and soil mortar to a height of 6 courses and resetting reused stone with a mixture of Portland Type I and II cement and sand. Entire area cemented was painted and spalled with a mixture of soil mortar of 3 parts soil to 1 part sand.

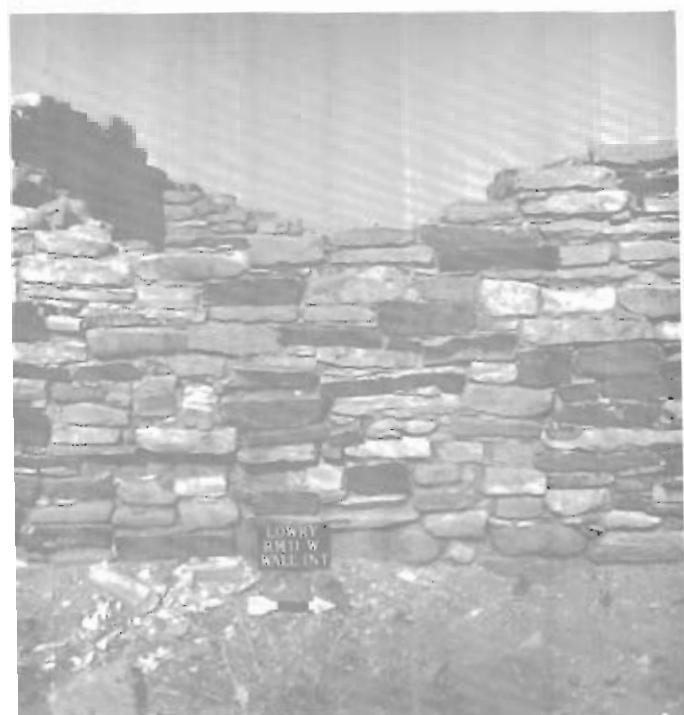
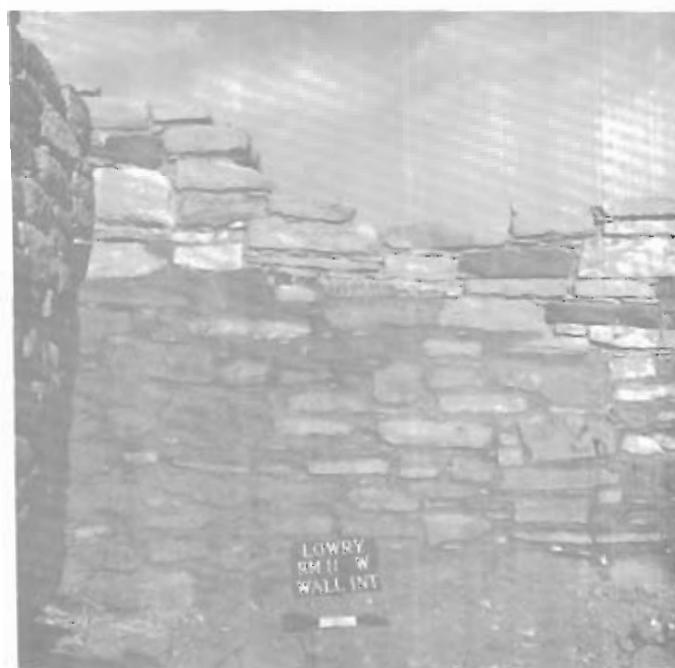
Photograph taken before restoration shows eroding sandstone blocks with
 several missing in the middle area of wall. This wall is built of a
 different type of sandstone not common at this ruin.

Figure 39. Room II, west interior wall. a, several stones had fallen from wall and stones of soft sandstone were eroding; b, eroding and missing stones were replaced.

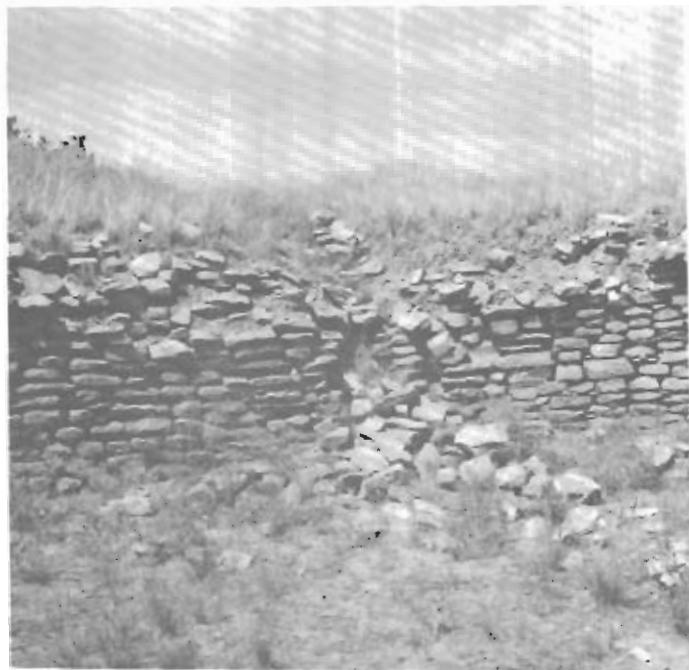
a

Figure 40. Great Kiva, stairway. a, stairway before stabilization in 1966; b, water runoff down stairway caused erosion behind wooden post steps.

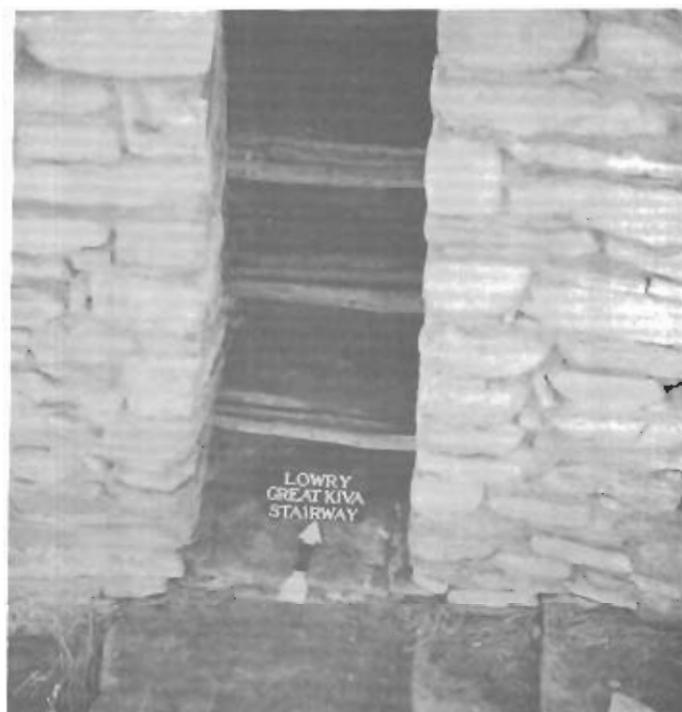
c

Figure 40. Great Kiva, stairway. c, stones behind wooden post steps were reset.

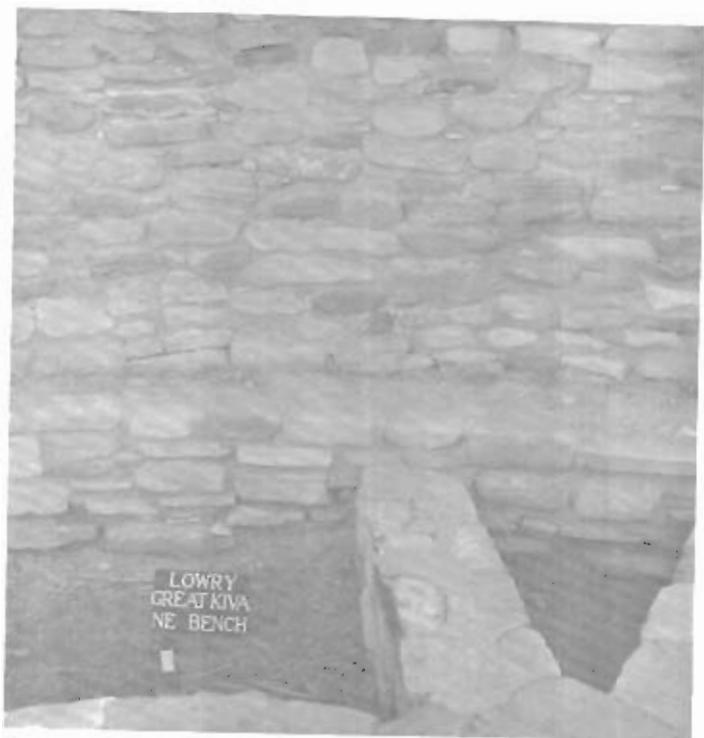
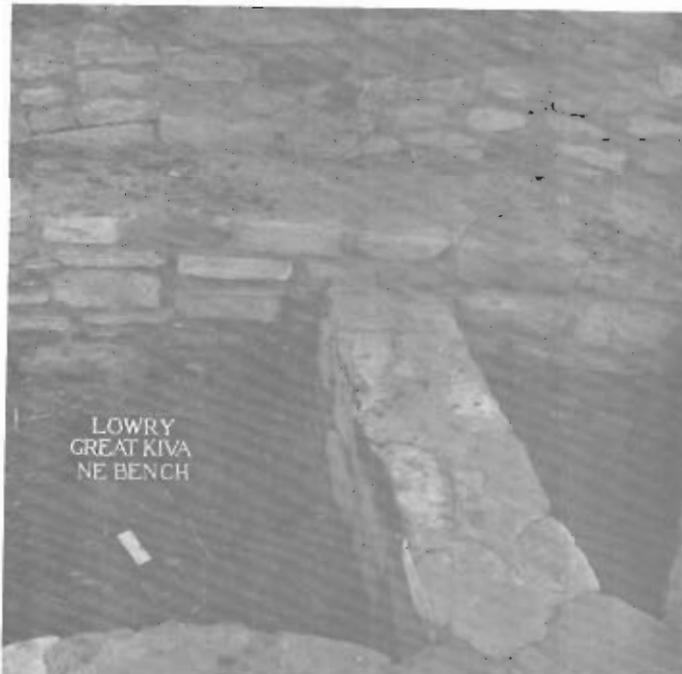
Figure 41. Great Kiva, northeast bench. a, mortar eroded beneath cement cap leaving large joints; b, all joints were grouted with soil mortar.

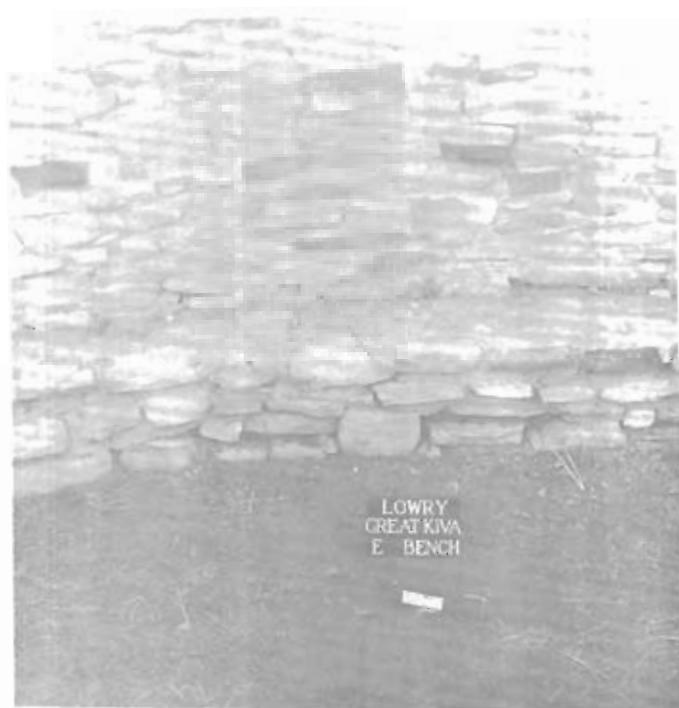
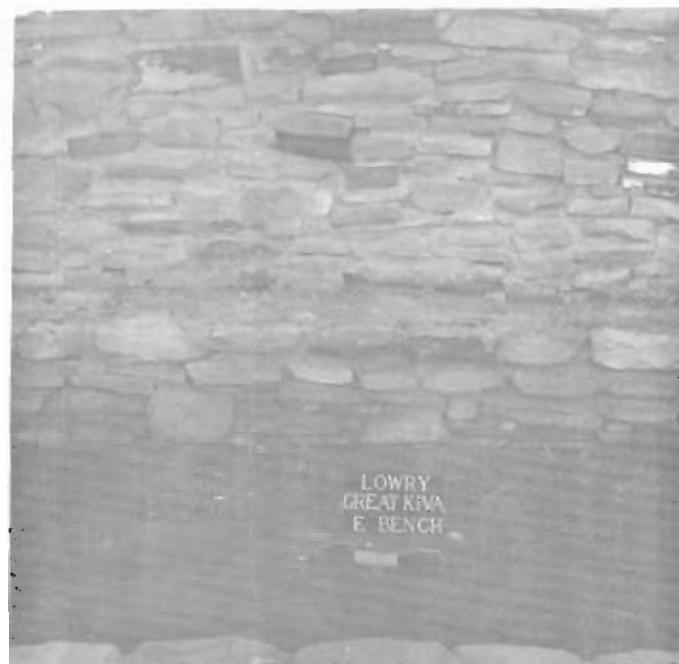
Figure 42. Great Kiva, east bench. a, mortar eroded beneath cement cap leaving large joints; b, all joints were grouted with soil mortar.

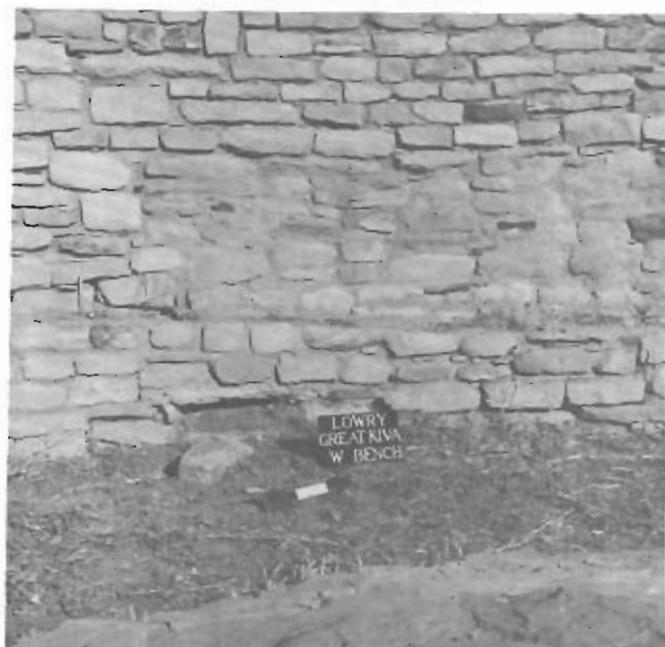
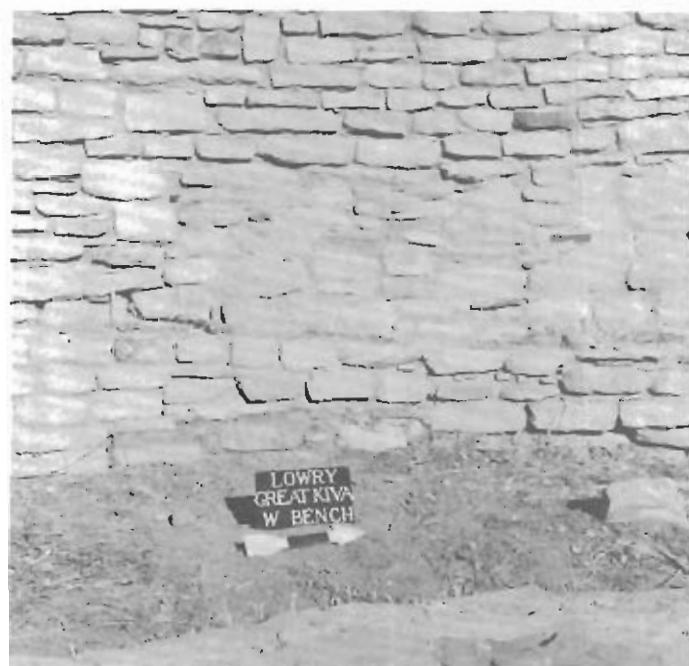
Figure 43. Great Kiva, west bench. a, one building stone was missing from bench wall; b, stone was reset and large joints were grouted.

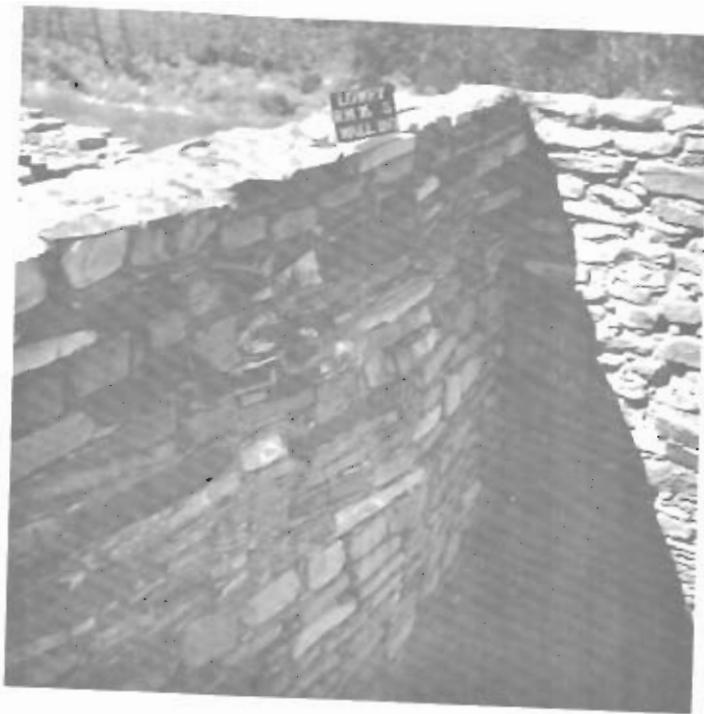
a

Figure 44. Room 16, south interior wall. a, lateral separation caused wall to bulge outward; b, view of exterior side of wall shows that damage did not extend through the thickness of the wall.

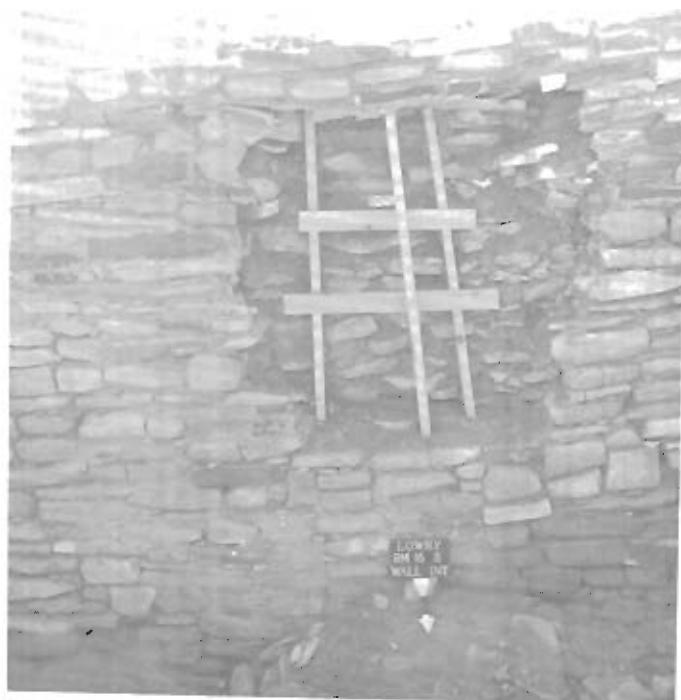
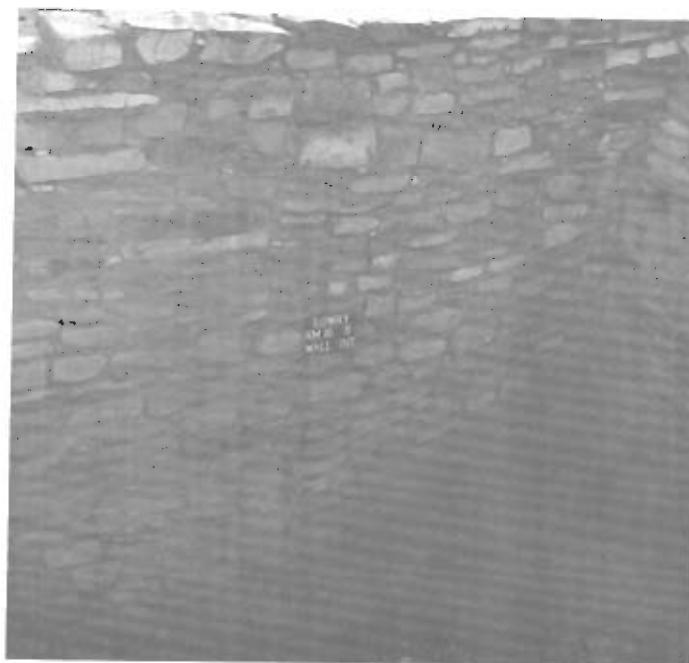
Figure 44. Room 16, south interior wall. c, wooden prop placed in the wall to support upper 2-3 courses after removal of the damaged portion; d, south view of wall after stabilization.
